Manhole Inspection Summary

Manhole # S47E__028MH

Insp Date: **7/29/08 11:17 AM**

Location Address: **Collington**

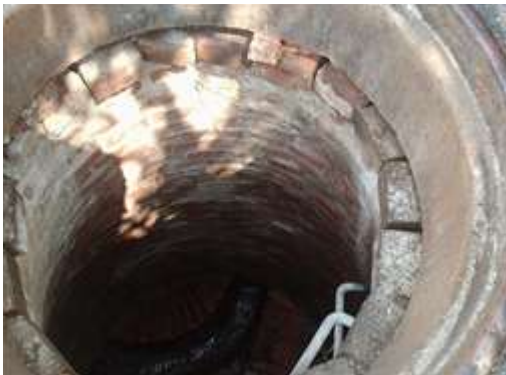
Defect 1

deterioration

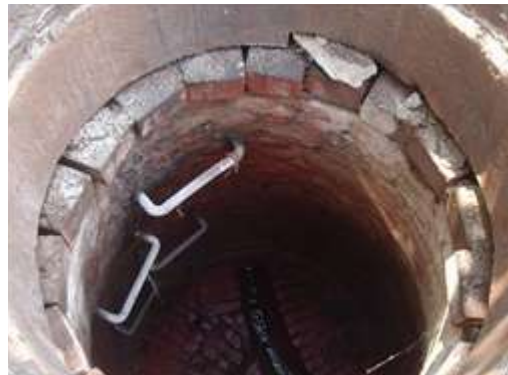
Defect 2

Condition: ☐ Sound ☐ Cracked ☐ Root Intrusion ☒ **Loose Brick** ☐ Deteriorated

Infiltration: ☐ None ☒ **Joint** ☐ Cracks ☒ **Mortar** ☐ Roots ☐ Wall

loose brick

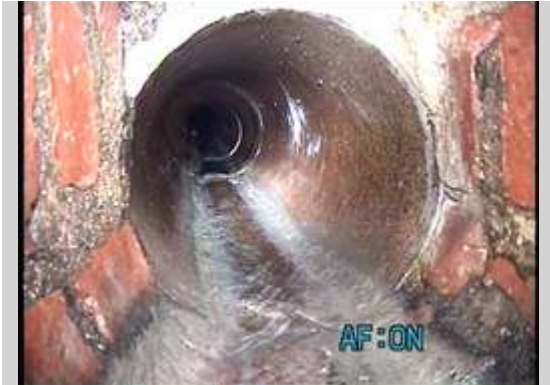
12 O'Clock Outflow

Pipe Height: **8.4** (in.) Rod and Bar (Angled)
Pipe Material: **Clay** ☐ Pipe Lined
Invert Depth: **9.40** (ft.) Flow Characteristics: **Fast**
Deposits: ☒ None ☐ Mud ☐ Sludge ☐ Debris ☐ Grease
Silt Depth: (in.) Deposits Extent:
Infiltration: **None** Pipe Seal Cond: **Sound**

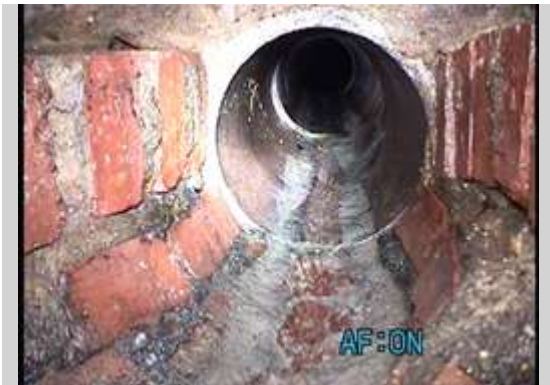
3 O'Clock Inflow

Pipe Height: **8.4** (in.) Rod and Bar (Angled)
Pipe Material: **Clay** ☐ Pipe Lined
Invert Depth: **9.20** (ft.) Flow Characteristics: **Fast**
Deposits: ☒ None ☐ Mud ☐ Sludge ☐ Debris ☐ Grease
Silt Depth: (in.) Deposits Extent:
Infiltration: **None** Pipe Seal Cond: **Sound**

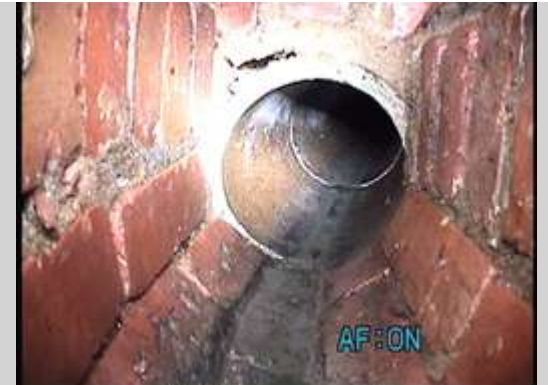
7 O'Clock Inflow

Infiltration: **None**

Pipe Seal Cond: **Sound**
